Subject: Clean Water Act Compliance Evaluation Inspection Report

**CWA COMPLIANCE EVALUATION INSPECTION REPORT
U.S. ENVIRONMENTAL PROTECTION AGENCY, REGION 5**

Facility: Calamity Knoll

Date of Inspection: April 24, 2014

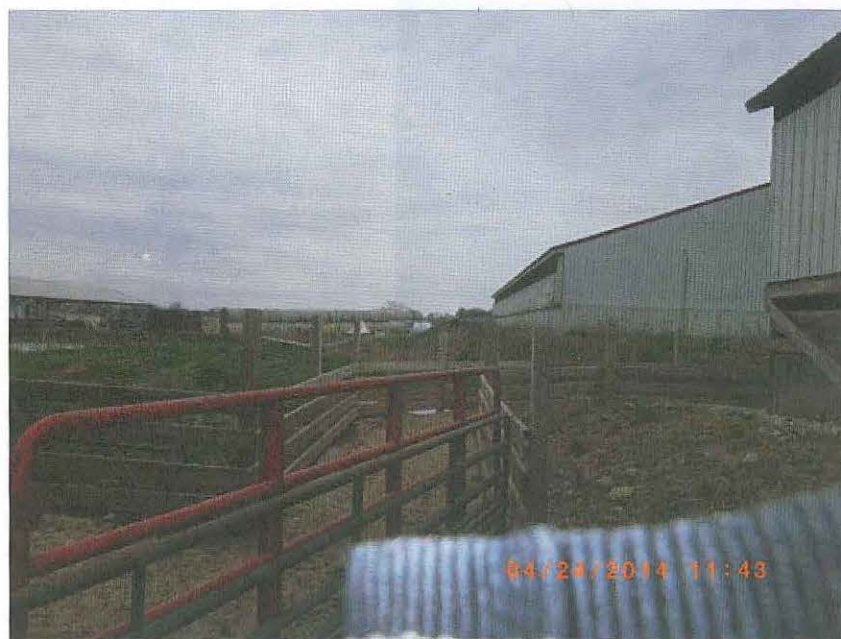
2: IMGP0628

I observed animal walkways near the Arnold and Sayle's Barn (Attachment 2: IMGP0627; IMGP0628). Portions of the walkway were sloped such that runoff from the animal walkway would flow toward the east to a pathway along the south end of the Coughlin Pit. The pathway hugs the south and then the east side of the Coughlin pit. Within this pathway at the southeast corner of the Coughlin pit, there was dark and septic smelling water (Attachment 2: IMGP0630; IMGP0631). There was dead vegetation throughout the pathway (Attachment 2: IMGP0630; IMGP0632). This pathway connected with a culvert at the northeast end of the Coughlin pit, which ran east under the access road and outlet into a pathway along the south side of Hartgarten Barn (Attachment 2: IMGP0633). The pathway continues east along the south side of the Hartgarten Barn (Attachment 2: IMGP0635). The surface drainage then followed the general direction as exhibited in the diagrams in Attachment 1.

Description: The animal walkway contained some manure and drained toward the east.

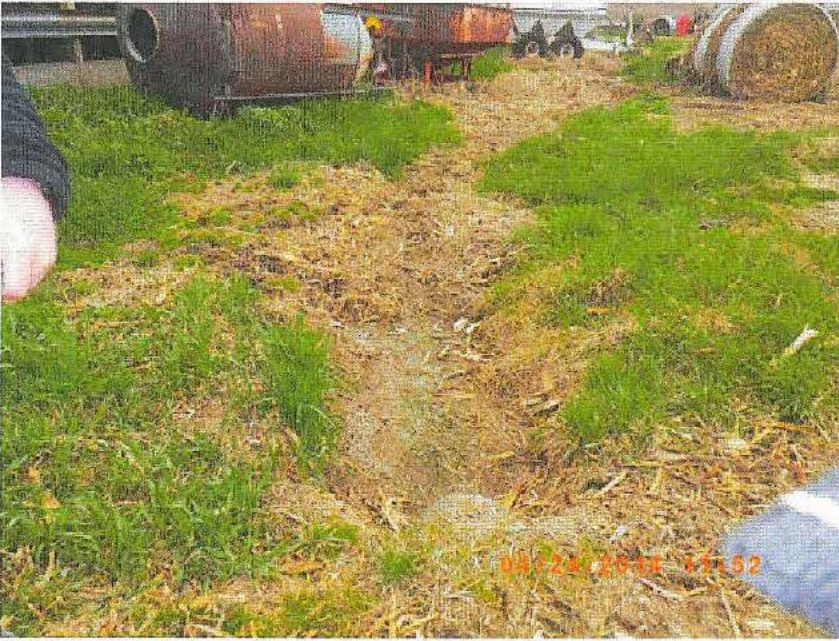
7: IMGP0633

Description: The pathway continued east along the south side of the Hartgarten Barn. There was dead vegetation throughout the pathway.

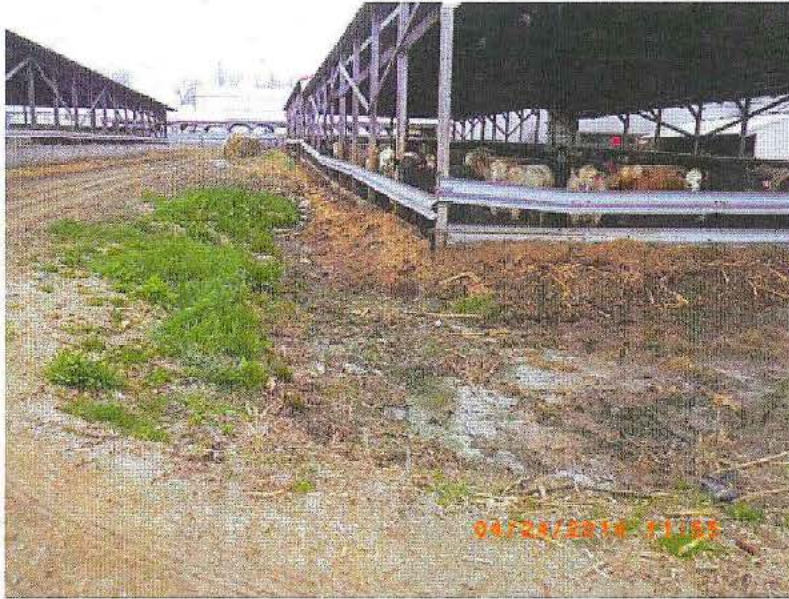
11: IMGP0637

In the southeast corner of Cow Palace, there was a culvert going under the access road to the east (Attachment 2: IMGP0637). Surface drainage flowing into this culvert would come into contact with manure and bedding around the outside of the Cow Palace (Attachment 2: IMGP0637; IMGP0638). I observed manure and bedding solids around and leading up to the entrance of the culvert. The culvert outlet to the east. I observed manure and bedding solids around the outlet of the culvert (Attachment 2: IMGP0640; IMGP0641; IMGP0642; IMGP0643). I observed manure and bedding solids throughout a pathway in the vegetated area that the culvert outlet into. Dead vegetation was observed throughout the vegetated area pathway. The Gilt Shed had open lots. Surface runoff from the open lots had no containment and would flow east (Attachment 2: IMGP0644). FOIA Exemption (b) (6) said that they have placed straw bales east of the Gilt Shed in the past to reduce runoff of manure from the Gilt Shed.

Description: A culvert near the southeast end of the Cow Palace Barn drains the area around the Cow Palace Barn to the east. There was a berm around the perimeter of the barn. The berm contained manure and bedding. Manure and bedding were observed on the ground around the intake of the culvert.

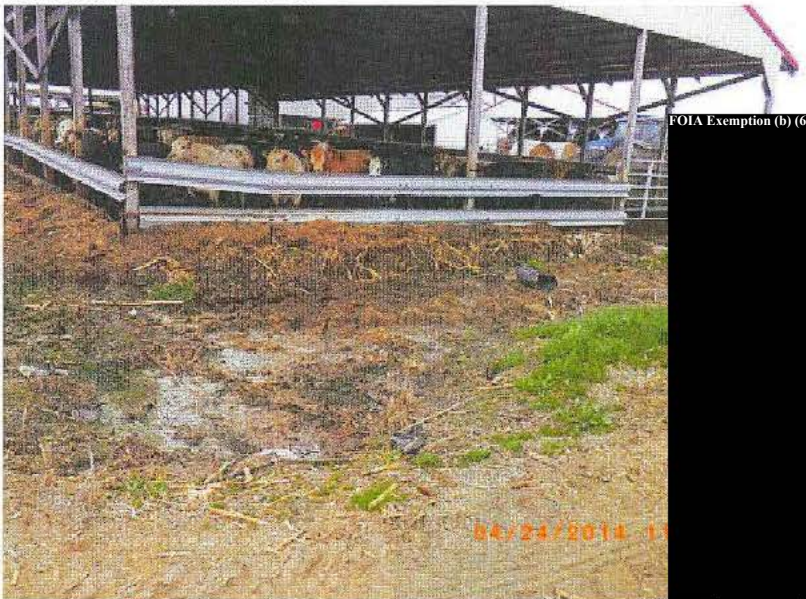
12: IMGP0638

Description: A culvert near the southeast end of the Cow Palace Barn drains the area around the Cow Palace Barn to the east. There was a berm around the perimeter of the barn. The berm contained manure and bedding. Manure and bedding were observed on the ground around the intake of the culvert.

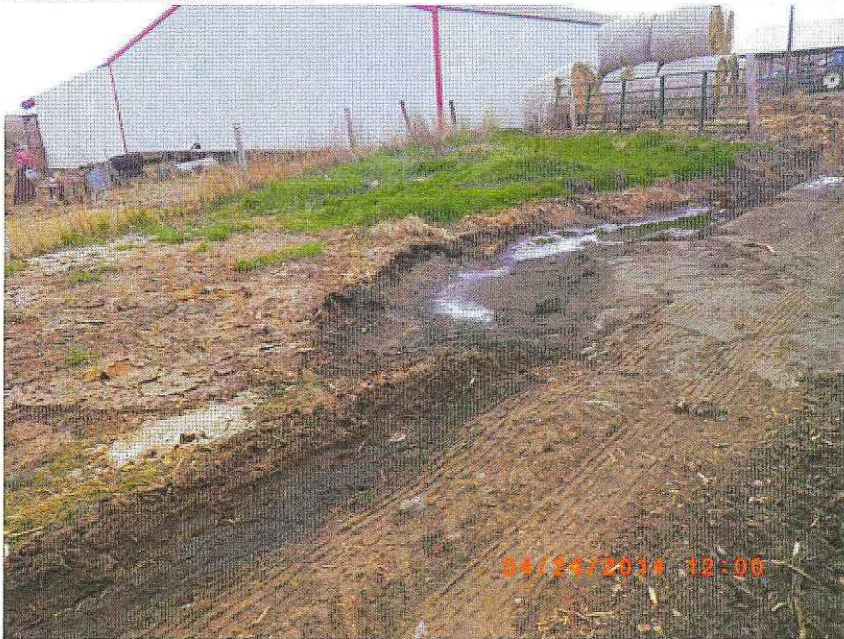
20: IMGP0646

I observed solids buildup and ponding of manure and process wastewater east of the Bruce Barn (Attachment 2: IMGP0646; IMGP0648). The open lots around the Bruce Barn and Robbie's Pen drained through Bruce Barn into this area before flowing into the field to the northeast of Bruce Barn (Attachment 2: IMGP0647). FOIA Exemption (b) (6) said that in the past they have placed hay bales into drainage pathway through the field to reduce runoff of manure from these open lots. The drainage pathway in the field flows to Spring Brook. The push out of manure was observed in the northeast corner of Bruce Barn (Attachment 2: IMGP0649). The surface runoff flows east. The facility had a stack of manure between Bruce Barn and Robbie's Pen (Attachment 2: IMGP0650). There was no containment for process wastewater generated at the manure stack.

Description: Manure and process wastewater was observed east of the Bruce Barn. This area is sloped such that drainage would flow northeast through the field to Spring Brook. There was no containment system for this manure and process wastewater.

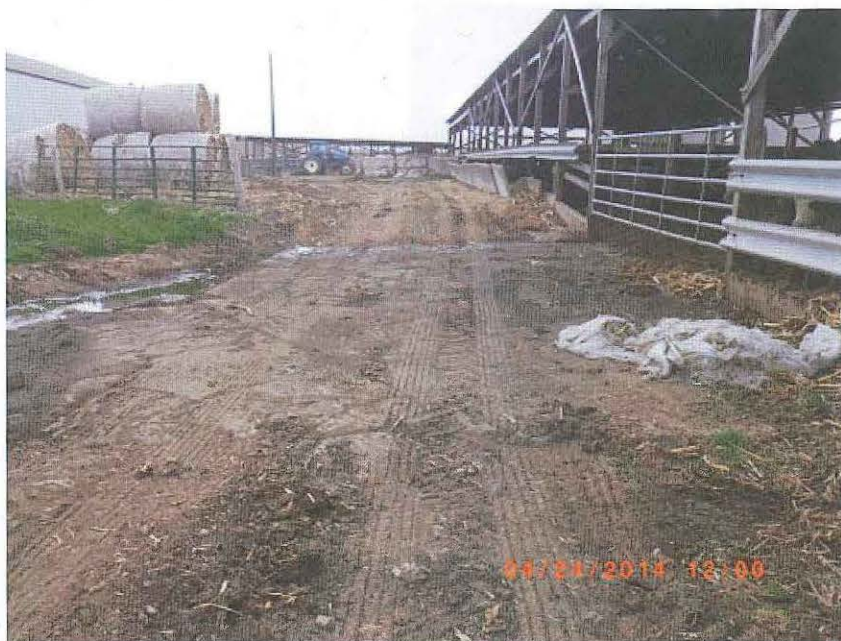
21: IMGP0647

Description: Manure and process wastewater from the Bruce Barn to the east. This area is sloped such that drainage would continue to flow northeast through the field to Spring Brook.

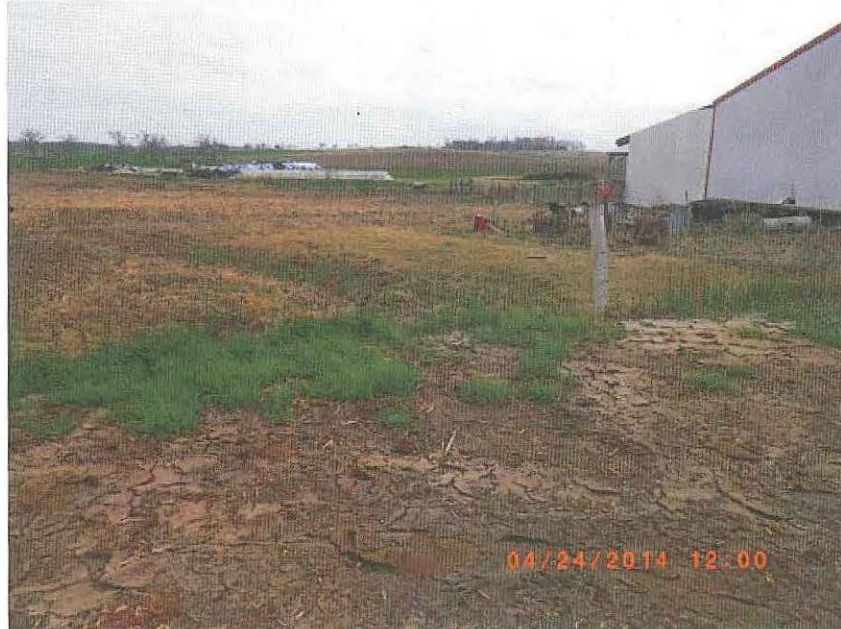
22: IMGP0648

Description: The manure solids can be seen in the area east of the Bruce Barn. Mr. [REDACTED] said that they have put round bails in the field northeast of the Bruce Barn to reduce the solids in stormwater that flowed from the areas east of the Bruce Barn. There were no round bails in the field during the inspection.

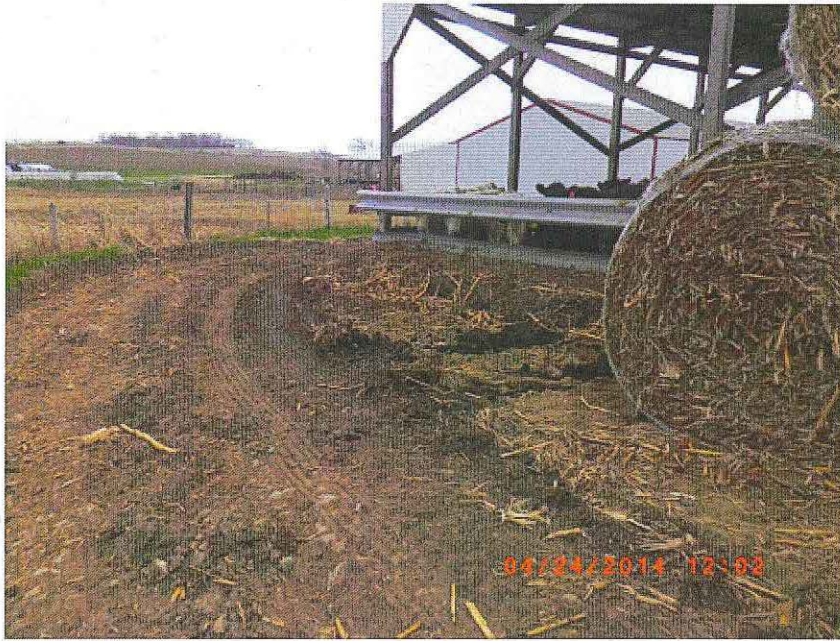
23: IMGP0649

Description: Manure and bedding were pushed out on the North side of the Bruce Barn.

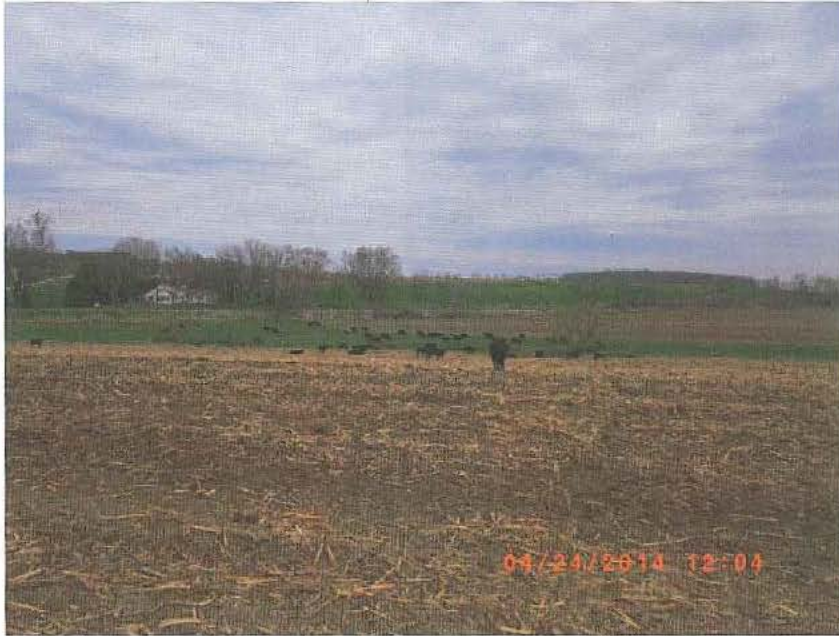
25: IMGP0651

We continued to the feed storage bunkers on the east end of the facility. Throughout the pasture to the north and east of the production area, cattle had direct access to Spring Brook (Attachment 2: IMGP0651). On the east corner of the feed bunkers there was a pipe which diverted process wastewater to a 4,000 gallon reception tank (Attachment 2: IMGP0653). During the inspection, the reception tank was full. The overflow from the reception tank would flow to the east and connect with a gully that flows to Spring Brook (Attachment 2: IMGP0654; IMGP0659). I observed a small stack of waste feed to the south of the feed bunkers (Attachment 2: IMGP0662).

Description: Cattle on pasture had direct access to Spring Brook.

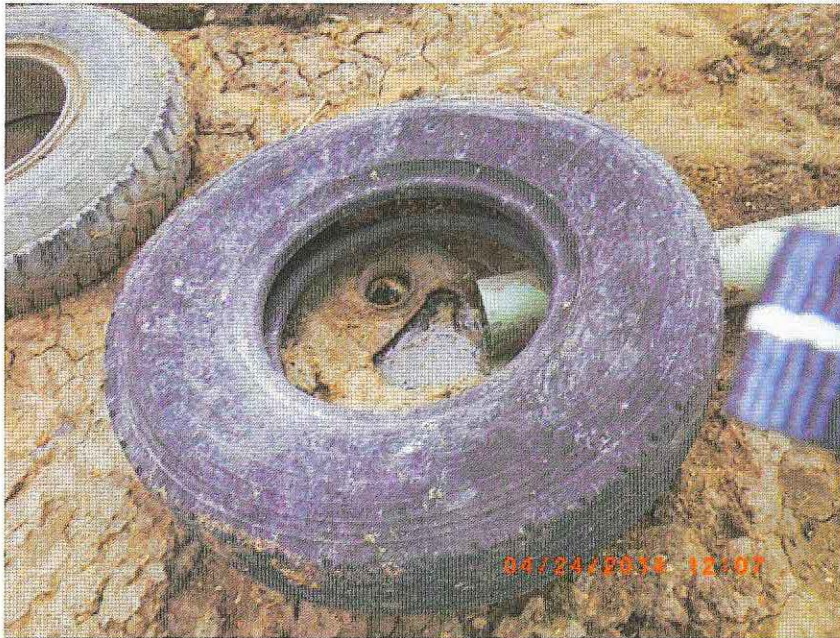
27: IMGP0653

Description: The bunker feed storage area drained through a pipe to an underground tank. The tank was full during the inspection. Any additional process wastewater flow to the tank would cause an overflow and flow east and then north to Spring Brook. The tire marks the inlet of the underground tank.

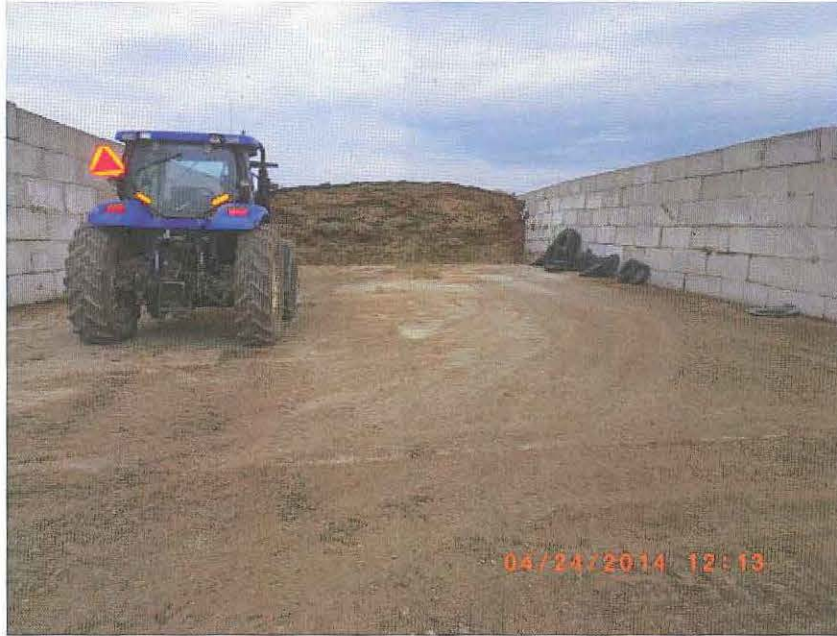
37: IMGP0663

Description: Process wastewater from the Feed Bunker is drained through a four inch PVC pipe to an underground tank that was full during the inspection.

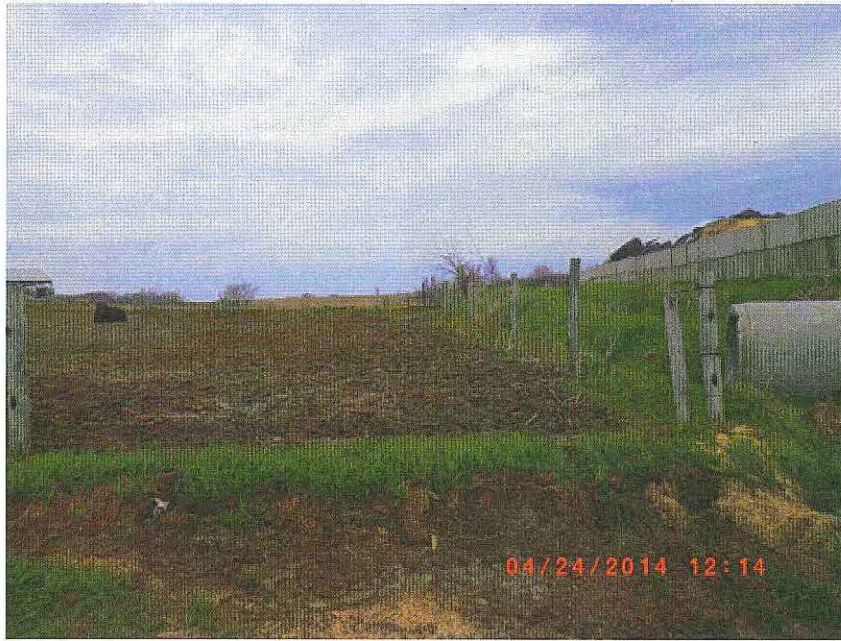
39: IMGP0665

I observed manure and feed from the East Lot that had run off the southeast corner and into the access road (Attachment 2: IMGP0665). This area appeared to drain to the east (Attachment 2: IMGP0666). In the lot to the south of the East Lot, I observed feed solids scattered throughout a feeding area (Attachment 2: IMGP0667). This area drained to the east. A large compost pile was located within the lot south of the East Lot (Attachment 2: IMGP0668; IMGP0673). I observe that there was no containment for any process wastewater generated at the compost pile. The compost area drained to the northeast to Spring Brook. I asked [FOIA Exemption (b) (6)] what kind of operational procedures he used for the compost pile. He said he just added carcasses and covered them. He did not have a monitoring or inspection plan for the compost pile. The compost pile was not in an approved structure.

Description: Feed lot is sloped such that surface drainage flows east. Manure and feed waste were observed on the East side of the open lot.

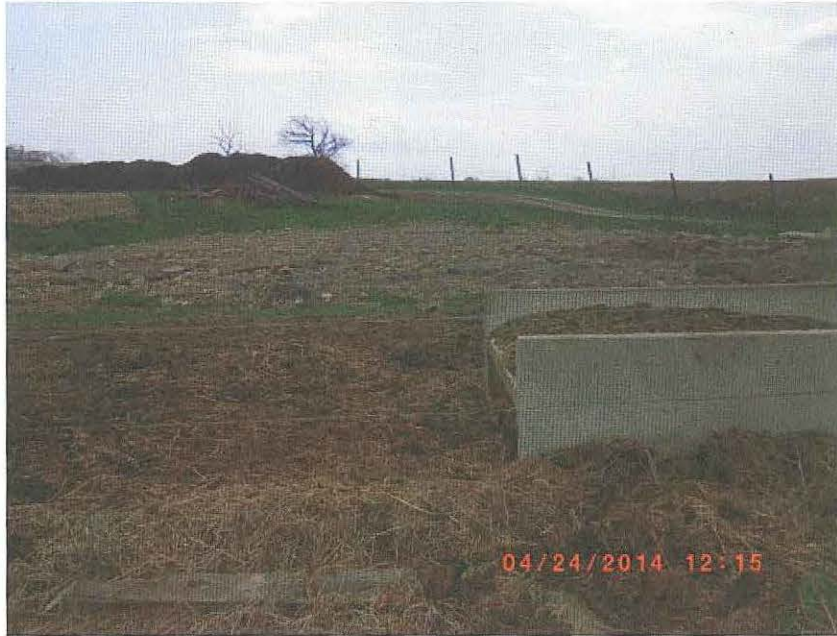
41: IMGP0667

Description: The mortality compost pile can be observed in the background. The mortality compost pile was not covered. Feed was observed on the ground.

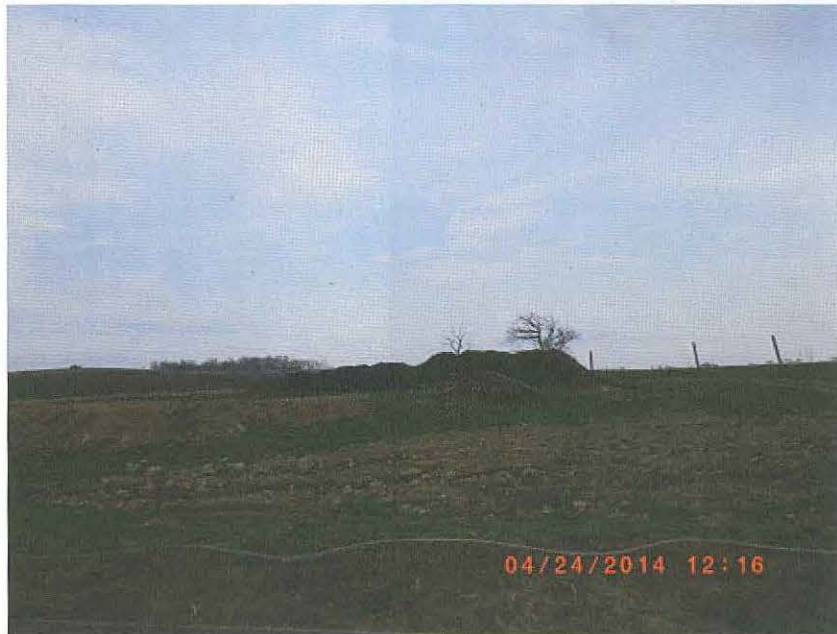
42: IMGP0668

Description: The mortality compost pile can be observed in the background. The mortality compost pile was not covered. Process wastewater from the compost pile had no containment.

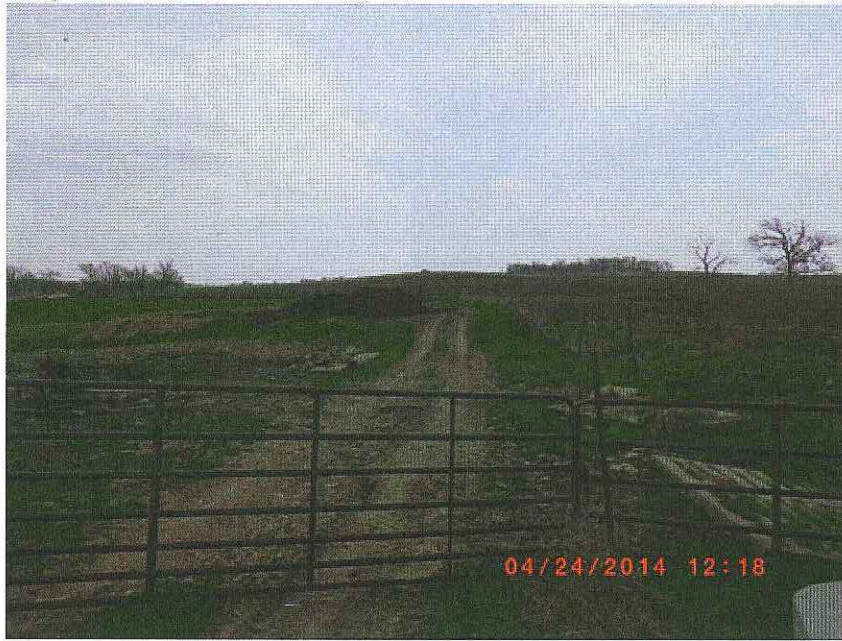
47: IMGP0673

Description: Mortality compost pile is located in the background. The mortality compost pile was not covered. Process wastewater from the compost pile had no containment.

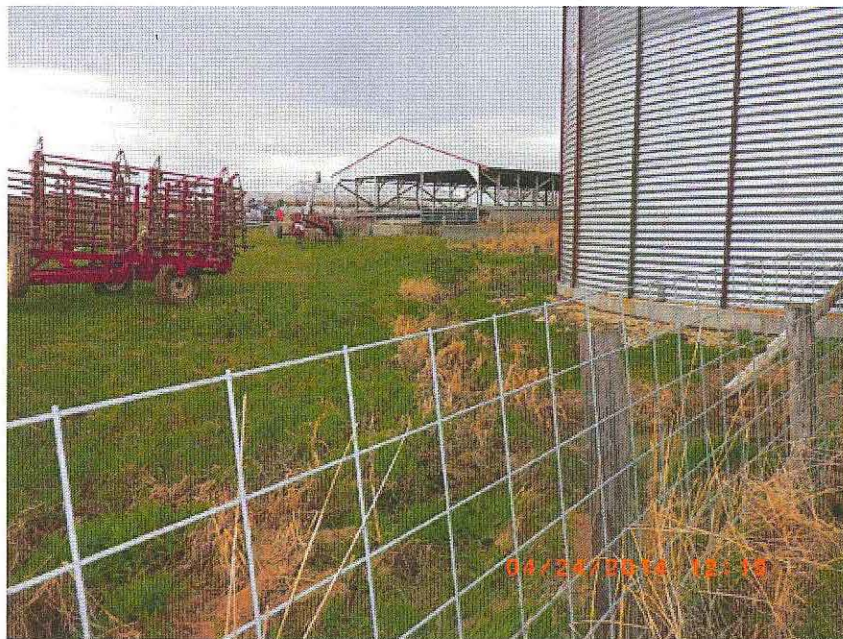
48: IMGP0674

I observed dead vegetation throughout the drainage pathway draining from east of the Hartgarten and Cow Palace barns (Attachment 2: IMGP0674). I observed manure and bedding solids throughout the pathway that came around both the south and the north end of the Silos (Attachment 2: IMGP0674; IMGP0684; IMGP0685). The drainage pathway continued east through a culvert under an access road (Attachment 2: IMGP0682). I observed manure and process wastewater at the inlet of the culvert, near the outlet of the culvert and in the drainage pathway (Attachment 2: IMGP0675; IMGP0676; IMGP0681; IMGP0683). The drainage pathway flows east and northeast to Spring Brook. The open lot between the Bruce Barn and Robbie's Pen drained to the east/northeast (Attachment 2: IMGP0687).

Description: Surface drainage flows east through this grassed area around the grain bins. Vegetation was dead throughout the pathway. Manure solids were observed throughout the pathway.

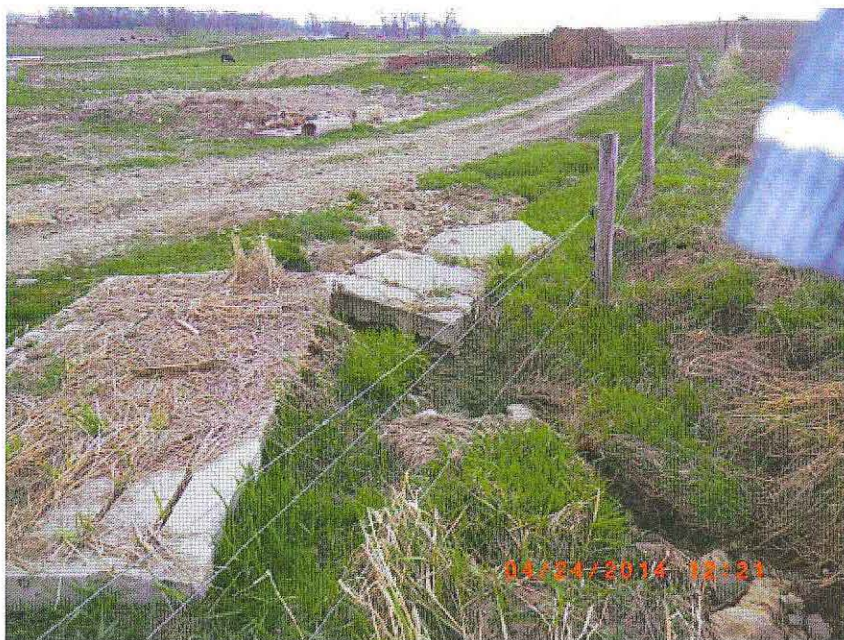
51: IMGP0677

Description: The pathway continues east through this area. Mortality compost pile is located in the background. The mortality compost pile was not covered. Process wastewater from the compost pile had no containment.

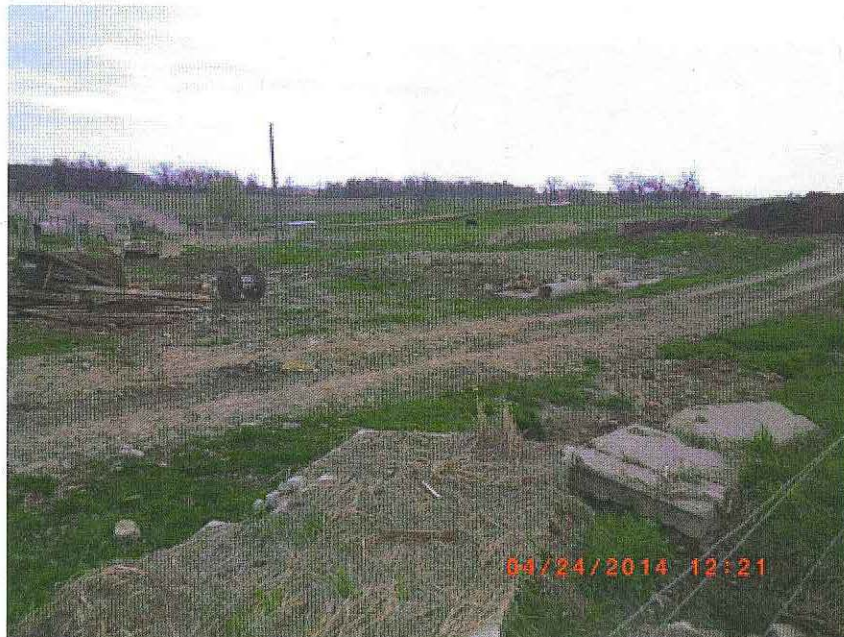
52: IMGP0678

Description: Surface drainage continues east through this area. Mortality compost pile is located in the background. The mortality compost pile was not covered. Process wastewater from the compost pile had no containment.

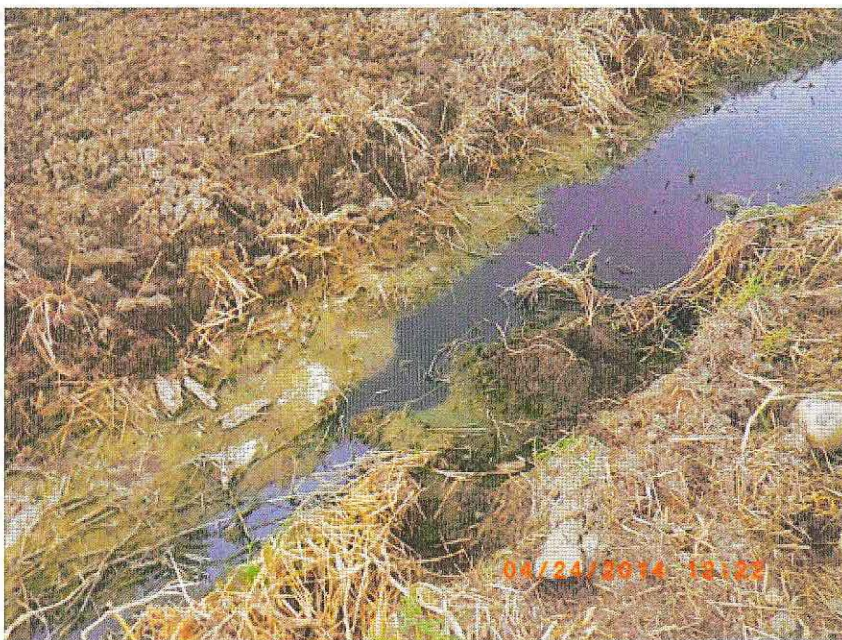
55: IMGP0681

Description: Water in the pathway was black and smelled like manure.

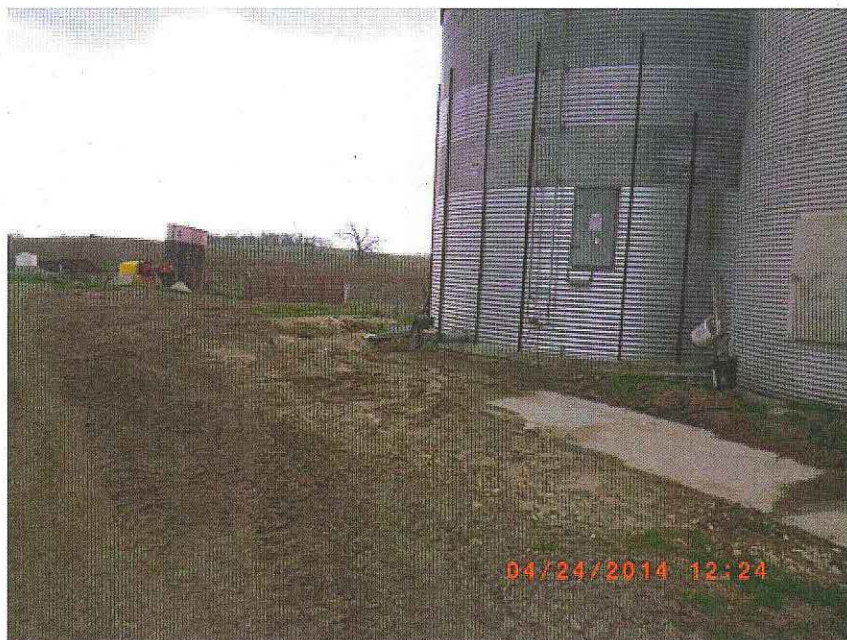
59: IMGP0685

Description: Manure solids were observed along the north end of the grain bins. This area drains east.

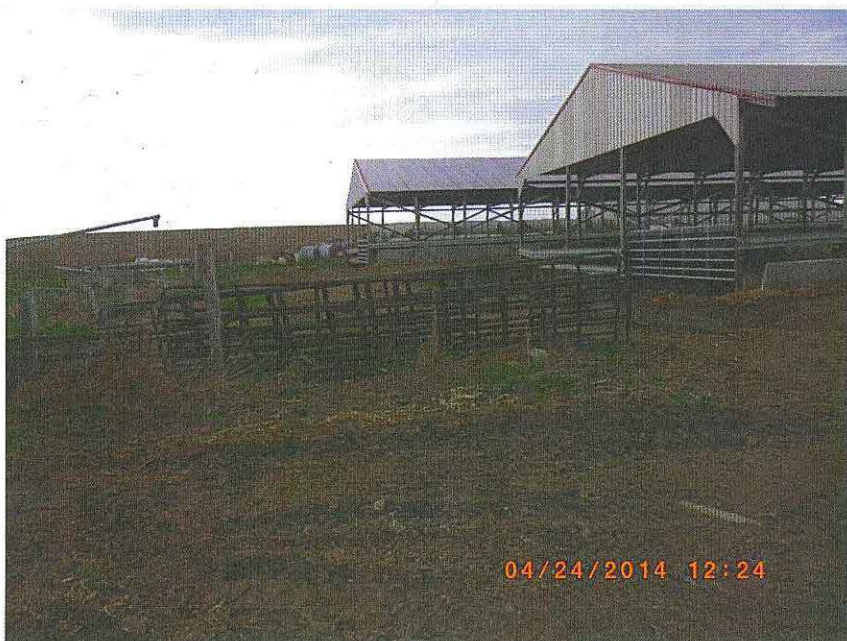
60: IMGP0686

Description: Manure solids and bedding solids were observed in the area east of the Gilt Shed.
